Inspection Report

www.edificeinspections.com

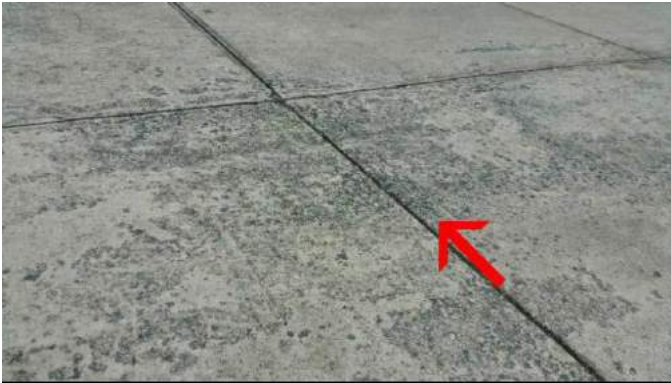
Condition: Surface deterioration and cracking were noted at the sections of the driveway closest to the street. The surface deterioration is not consistent with normal wear for the age of the property. Additional surface deterioration should be expected over time. The rear of the driveway has been recently replaced. Some typical cracks were noted at this section of the driveway.

Surface deterioration @ driveway

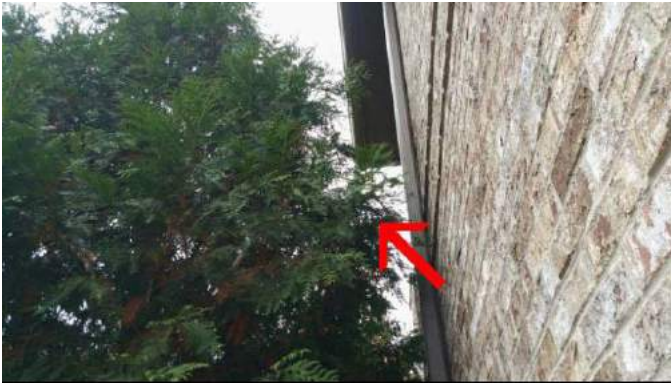
Condition: There are trees/bushes in contact with the building at the right side. Trimming of all trees/bushes away from the building is recommended to avoid damage to siding, trim or roofing. Trimming bushes away from the air conditioning units is recommended to improve efficiency of the units. Remedy of these conditions by a qualified landscaping contractor is recommended.

Trim away @ right side

1. There are trees/bushes in contact with the building at the right side. Trimming of all trees/bushes away from the building is recommended to avoid damage to siding, trim or roofing.

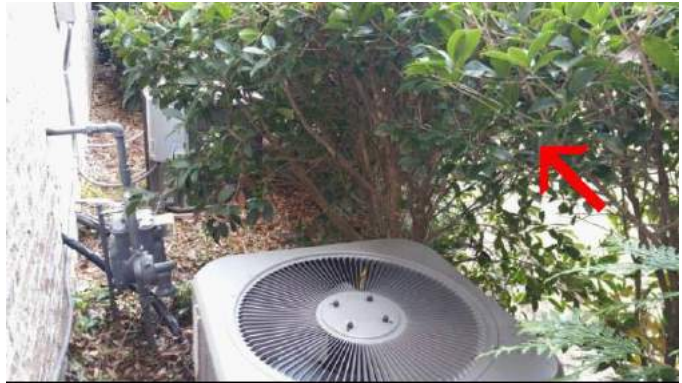
Trim away from A/C units

Trimming bushes away from the air conditioning units is recommended to improve efficiency of the units.

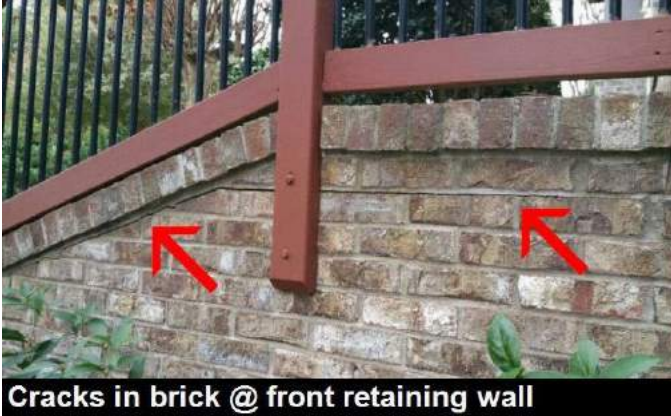
Condition: Cracking and displacement was noted at the brick veneer at the front right corner retaining wall. This movement is related to cracking and displacement noted at the front porch. Periodic monitoring for additional movement is recommended. If additional movement occurs further evaluation by a qualified, registered engineer is recommended.

Cracks in brick @ front retaining wall

2. Cracking and displacement was noted at the brick veneer at the front right corner retaining wall. This movement is related to cracking and displacement noted at the front porch.

Periodic monitoring for additional movement is recommended. If additional movement occurs further evaluation by a qualified, registered engineer is recommended.

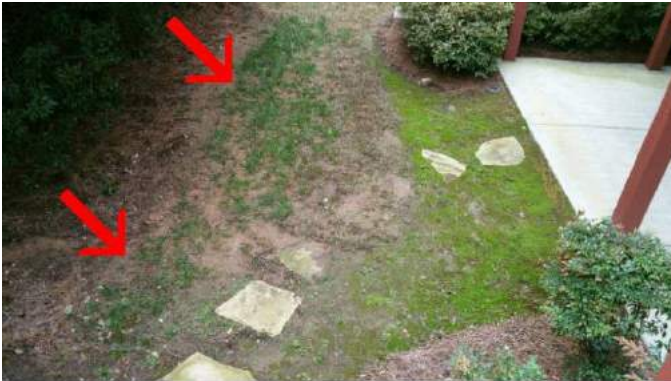
Condition: Evidence of poor drainage was noted at the left front corner of the backyard and in the backyard rear of the deck. Re-grading of these areas or installation of underground drainage systems is recommended by a qualified landscaping contractor.

Poor drainage @ left side of backyard

3. Evidence of poor drainage was noted at the left front corner of the backyard and in the backyard rear of the deck. Re-grading of these areas or installation of underground drainage systems is recommended by a qualified landscaping contractor.

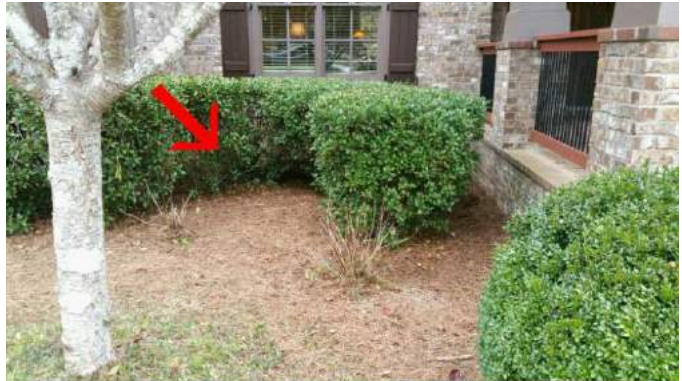
Grade(s) are not properly sloped away from the house in the following location(s): front of the house left of the front door. Construction standards in effect at the time the building was constructed required grades to slope away from the building 6 inches in the first 10 feet. Although no water entry resulting from these conditions was noted at the time of the inspection improving the grading in these areas is recommended to help prevent future water entry. Recommend repairs be made by a qualified landscaping contractor.

Improper grading @ front of house

Grade(s) are not properly sloped away from the house in the following location(s): front of the house left of the front door. Construction standards in effect at the time the building was constructed required grades to slope away from the building 6 inches in the first 10 feet. Although no water entry resulting from these conditions was noted at the time of the inspection improving the grading in these areas is recommended to help prevent future water entry. Recommend repairs be made by a qualified landscaping contractor.

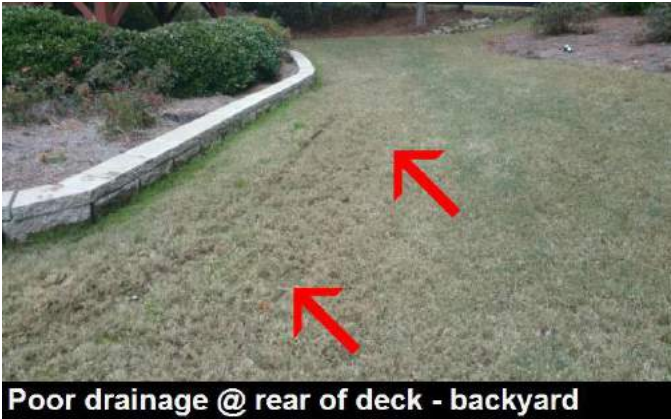
Poor drainage @ rear of deck - backyard

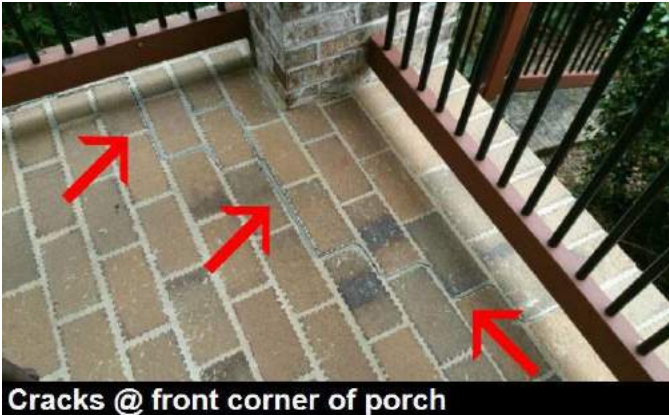
Condition: Cracking and displacement was noted at the front right corner of the front porch. This movement

appears to be related to cracking and displacement of the retaining wall next to the porch. Periodic monitoring for additional movement is recommended. If additional movement occurs further evaluation by a qualified, registered engineer is recommended.

Periodic monitoring for additional movement is recommended. If additional movement occurs further evaluation by a qualified, registered engineer is recommended.

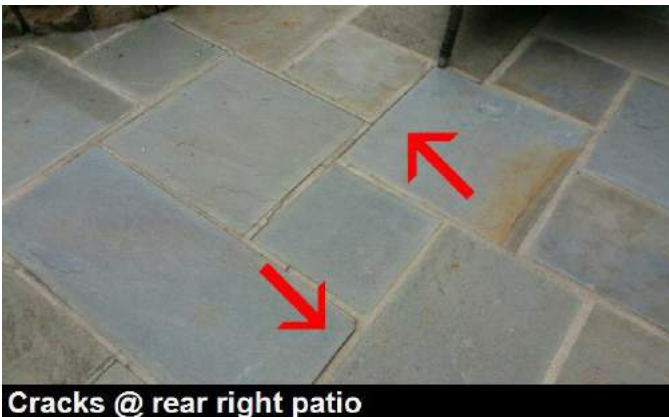
Condition: Cracking and displacement was noted at the stone tile patio near the fire pit. Cracking and vertical displacement was noted at the rear left corner of the concrete patio near the deck post. Additional cracking or displacement of either patio may require repairs. Periodic monitoring for additional movement is recommended.

Cracks @ rear right patio

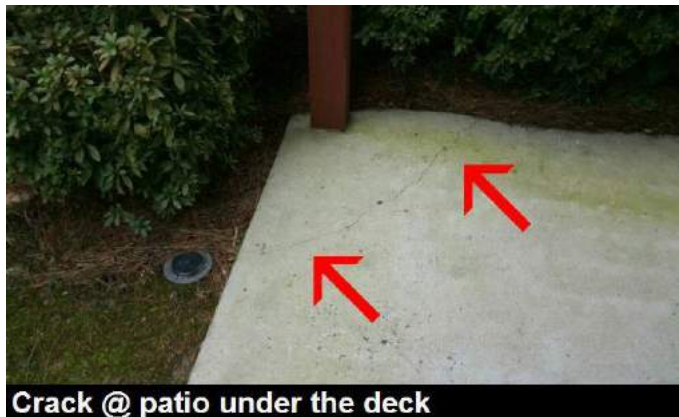
Crack @ patio under the deck

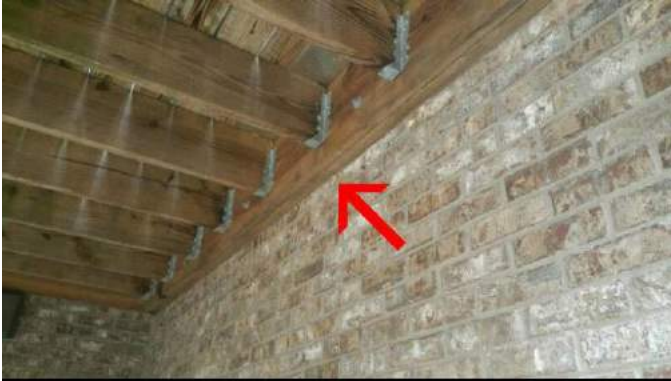
The deck has been attached to the house over the brick veneer. This type of connection is no longer considered adequate. Although the deck construction is typical for its age it does not comply with current deck safety standards. Re-construction of the deck to current standards should be considered to maximize safety. See the following link for additional information on deck construction standards https://dca.ga.gov/sites/default/files/2014_ircprescriptivedecks.pdf.

Deck attached over the brick veneer

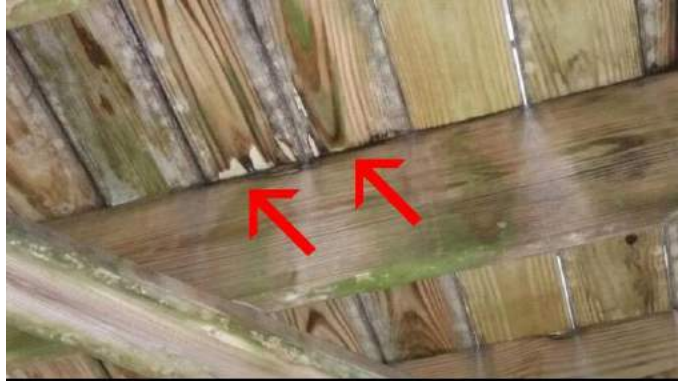
Decay of deck surface boards

Deteriorated deck surface boards were noted. This deterioration was visible from the bottom of the deck. Replacement of these boards is recommended.

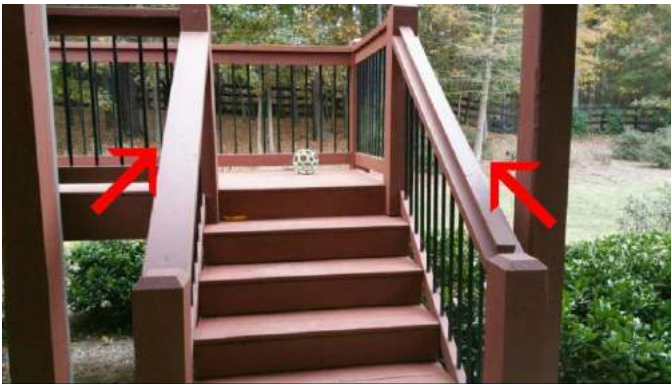
Condition: The stair handrail dimension is larger than allowable by construction standards at the time the home was built. Deteriorated deck surface boards were noted. This deterioration was visible from the bottom of the deck. Replacement of these boards is recommended. One guard rail pickett was missing from the deck stairs guardrail. Replacing the pickett is recommended. The guardrail at the left side of the deck is loose. This is a potential safety hazard. Repairs should be made by a licensed general contractor.

No gripable handrail installed

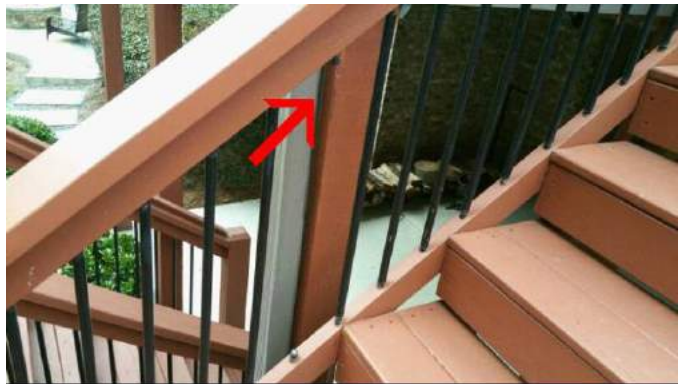
Railing picket is missing

One guard rail pickett was missing from the deck stairs guardrail. Replacing the pickett is recommended. The guardrail at the left side of the deck is loose. This is a potential safety hazard. Repairs should be made by a licensed general contractor.

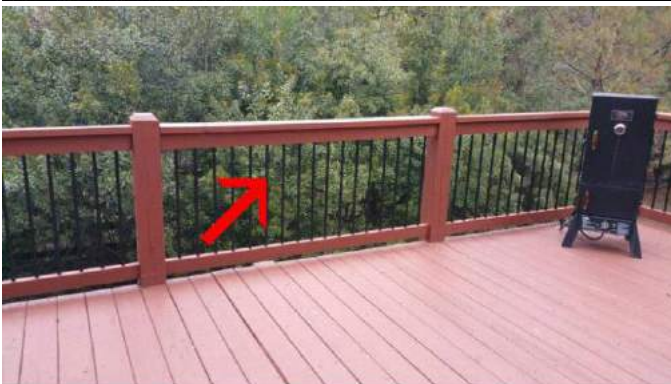
Railing is loose from the deck

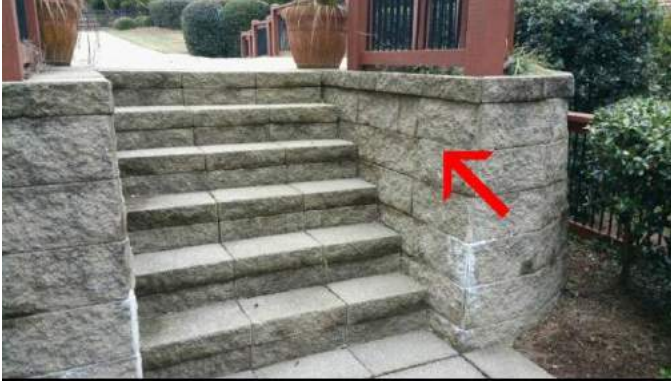
The block steps located at the rear of the driveway do not have graspable handrails installed. This is a potential safety hazard. Improvements should be made for enhanced safety by a licensed general contractor.

No handrail @ backyard stairs

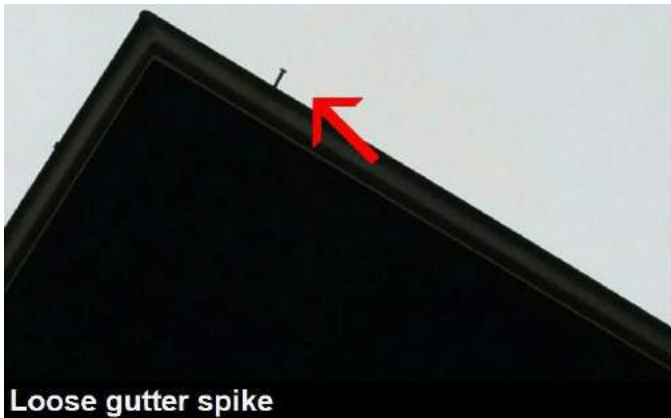
Type:	Metal.
Condition:	<p>Loose gutter spikes were noted at the right front corner of the front porch. Re-securing these sections of gutter is recommended.</p> <p>Repairs should be made by a qualified contractor.</p>

Loose gutter spike

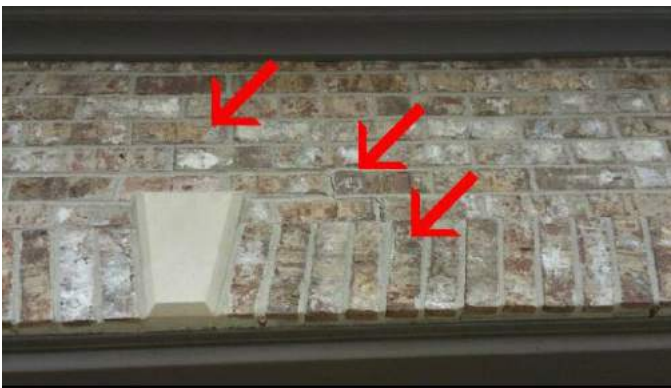
Condition: Cracks were noted in the mortar above the two car and single car garage doors. These cracks appear to be the result of deflection of the house frame. Filling the voids in the mortar joints is recommended to prevent water entry. Recommend further evaluation and repair as necessary by a licensed general contractor.

Crack above 2 car garage door

6. Cracks were noted in the mortar above the two car and single car garage doors. These cracks appear to be the result of deflection of the house frame. Filling the voids in the mortar joints is recommended to prevent water entry. Recommend further evaluation and repair as necessary by a licensed general contractor.

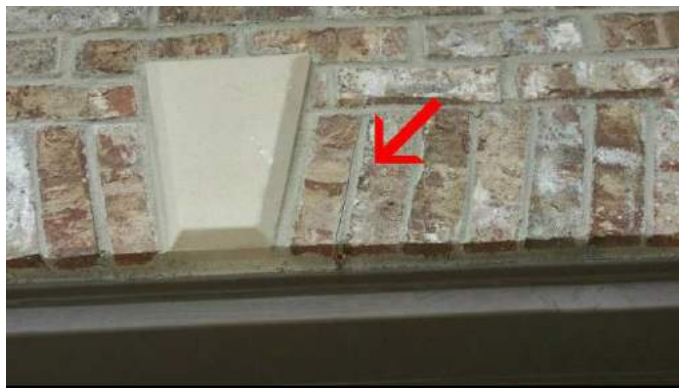
Crack above 1 car garage door

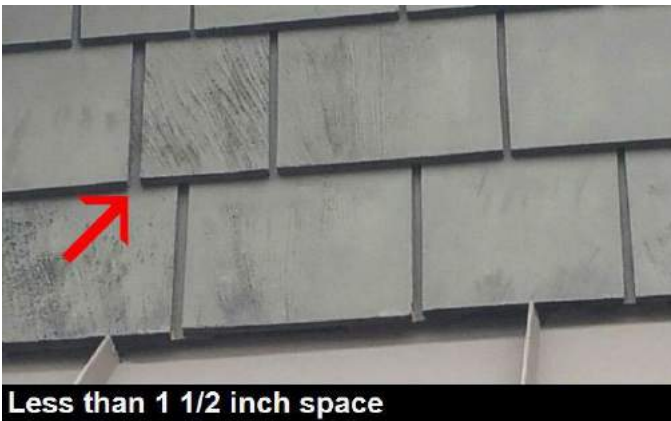
Improper spacing between adjacent courses of the wood shingle siding was noted at the front of the house over the two car garage. Less than 1 1/2 inches of space was noted between adjacent courses. Although improperly installed no problems were noted as a result of this condition.

Less than 1 1/2 inch space

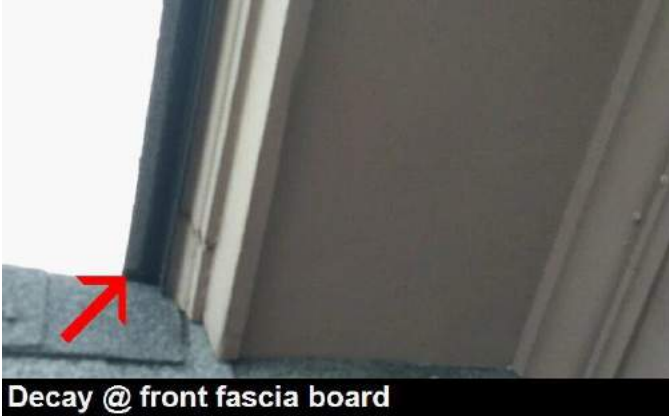
Condition: Damage/decay was noted in the following location(s): fascia near the front left corner of the house. Recommend repairs be made by a licensed general contractor.

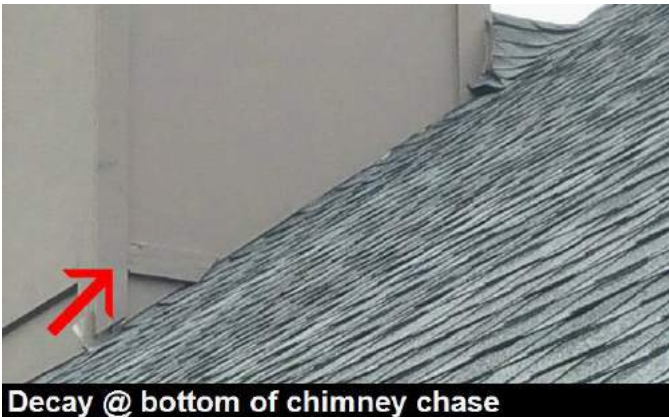
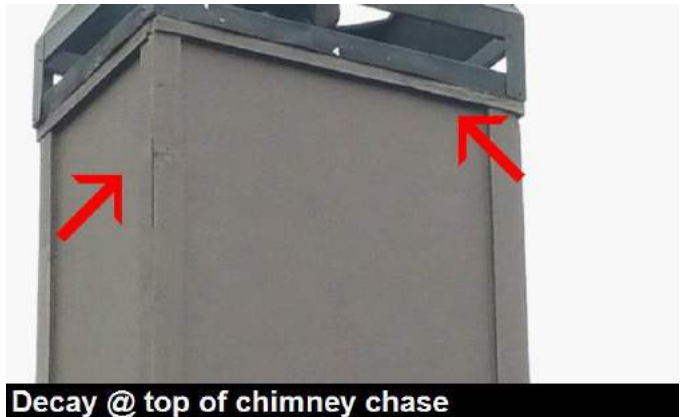
Condition: Damage/decay noted in the following location(s): chimney chase trim in several locations. Condition(s) should be repaired/replaced as necessary by a licensed general contractor.

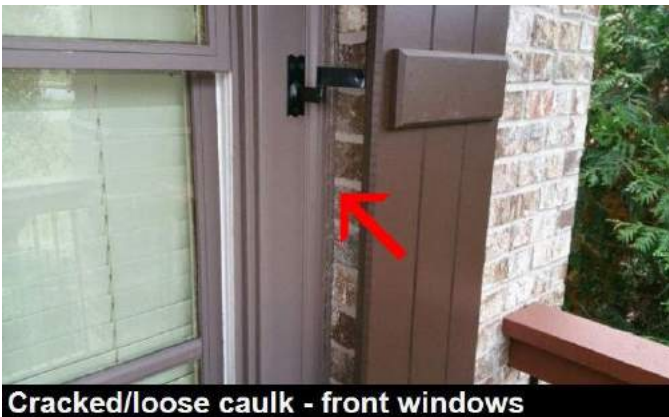
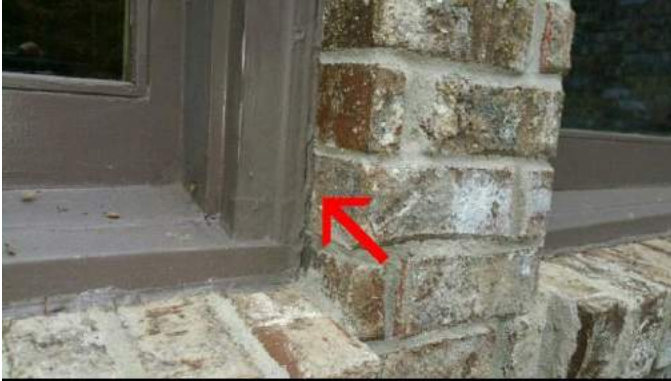
Cracked and loose caulking was noted at the front porch front right window, rear family room windows. Re-caulking and painting these areas is recommended to prevent wood decay and water entry. Repairs should be made by a qualified contractor.

Cracked/loose caulk - rear windows

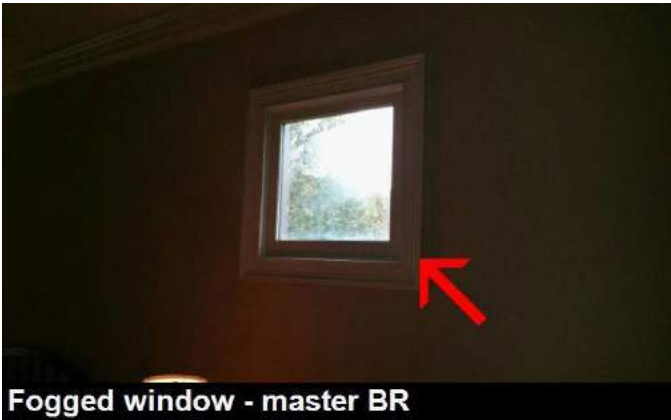
Condition: Thermopane seals failed in the following location(s): Two master bedroom right side windows. Replacement of all glass panes with broken thermoseals by a licensed general contractor is recommended.

Fogged window - master BR

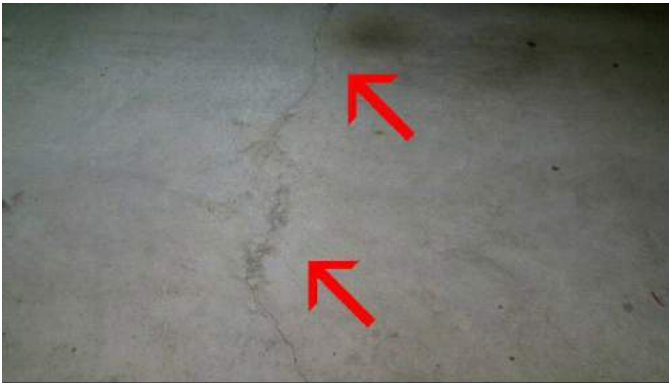
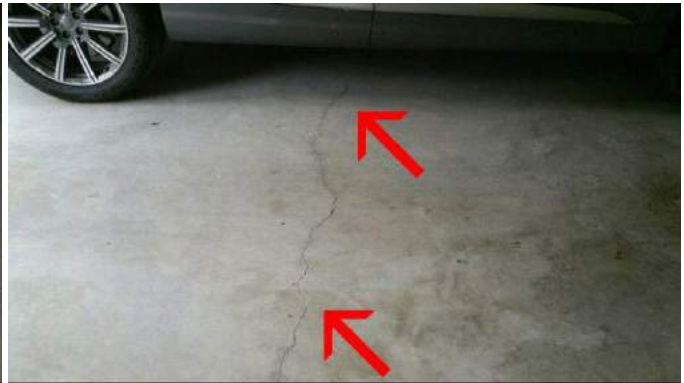
Condition: Typical cracks noted at both garage floors. Periodic monitoring for additional movement is recommended.

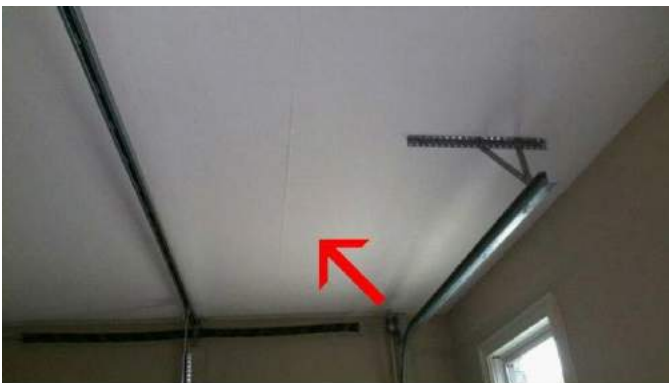
Ceiling: A crack was noted at the single car garage ceiling. Repairs should be made by a licensed general contractor.

Crack @ 1 car garage ceiling

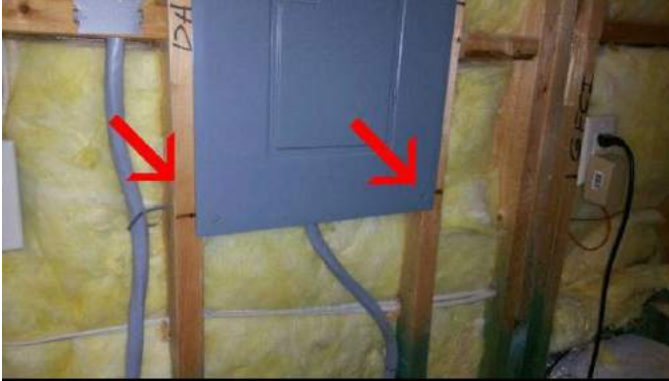
Description:	Circuit breakers.
Primary Panel Location(s):	Basement.
240V Conductor Material:	Copper, Aluminum.
120V Conductor Material:	Copper.
Wiring Method:	Non-metallic cable (Romex)
Primary Panel(s) Condition:	<p>The panel is not completely labeled. Having the panel properly labeled is recommended.</p> <p>Four panel cover screws are missing. Replacing the missing screws with appropriate panel cover screws is recommended.</p> <p>Further evaluation and correction of all electrical problems as necessary by a qualified, licensed electrician is recommended.</p>

Missing cover screws

11. The panel is not completely labeled. Having the panel properly labeled is recommended. Four panel cover screws are missing. Replacing the missing screws with appropriate panel cover screws is recommended. Further evaluation and correction of all electrical problems as necessary by a qualified, licensed electrician is recommended.

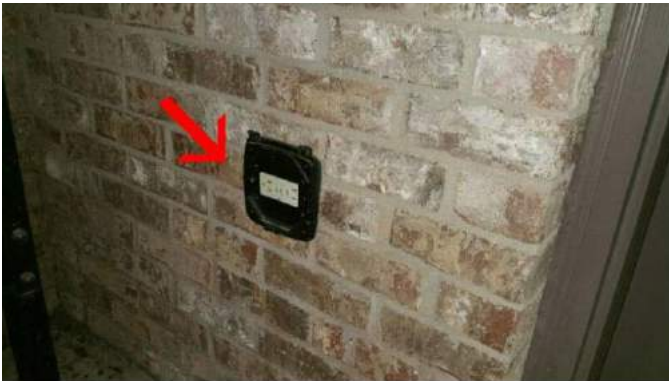
Missing cover

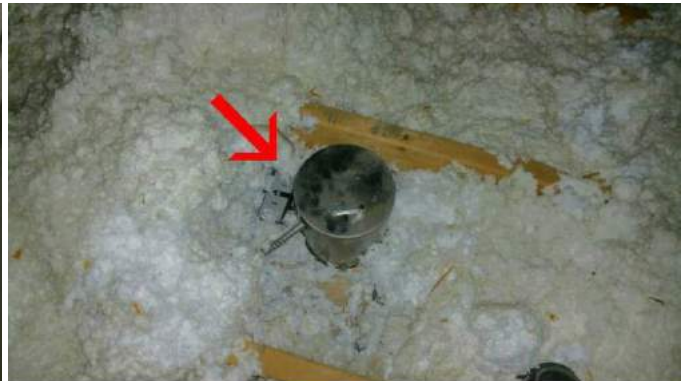
Condition: Insulation is in contact with recessed light cans in the attic. Unless the lights are rated for insulation contact (IC) the insulation must be 3 inches away from the cans to avoid over heating.
A broken weatherproof cover was noted at the receptacle located at the right side of the house next to the air conditioners.
A missing weatherproof cover was noted at the rear receptacle next to the basement french doors.
Further evaluation and correction of all electrical problems as necessary by a licensed electrician is recommended.

Recessed light in contact with insulation

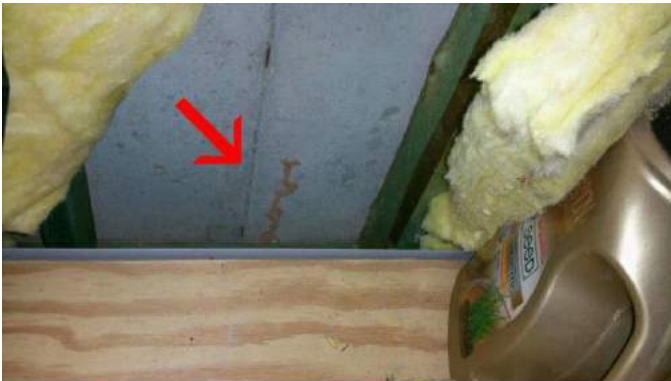
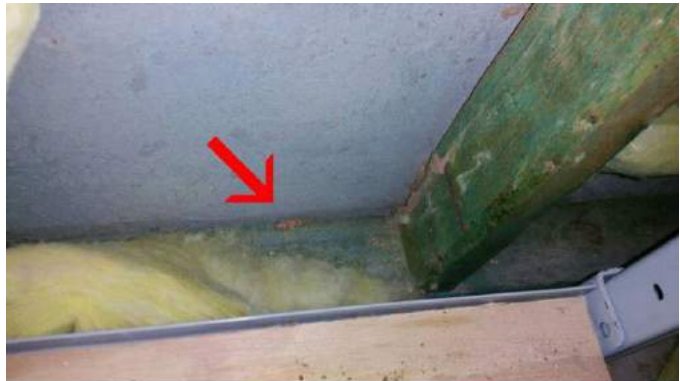
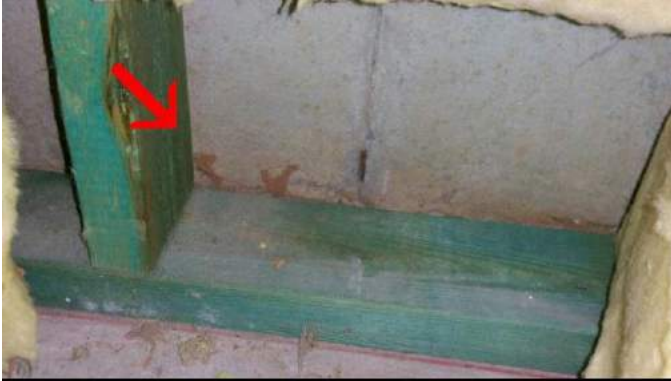
Condition:	An active infestation by wood destroying insects was observed in the following location(s): left side and front left corner of the basement. Further evaluation and treatment is recommended by a qualified pest control contractor.
-------------------	---

Termite tunnel

Termite tunnels

12. An active infestation by wood destroying insects was observed in the following location(s): left side and front left corner of the basement. Further evaluation and treatment is recommended by a qualified pest control contractor.

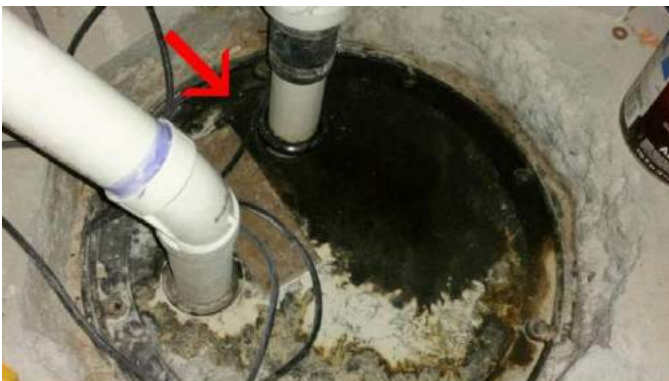
Condition: The ejector pump lid is not properly sealed. Missing bolts were noted from the lid. The smell of sewer gas was noted around the unit during operation. Repairs should be made by a qualified, licensed plumber.

Not properly sealed

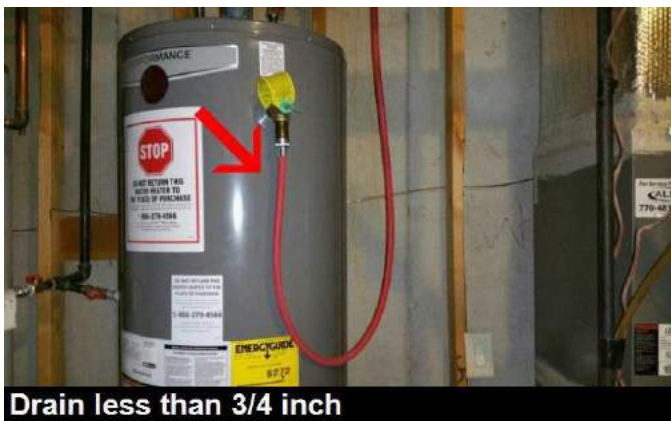
Condition: The pipe on the temperature pressure relief valve discharges in an upward direction. The valve manufacturer requires that the valve discharge downward or be able to be drained after the valve is tested. The pipe on the temperature pressure relief valve has been reduced in size. A minimum pipe diameter of 3/4 inch is required.
Repairs should be made by a qualified, licensed plumber.

Drain less than 3/4 inch

The pipe on the temperature pressure relief valve has been reduced in size. A minimum pipe diameter of 3/4 inch is required. Repairs should be made by a qualified, licensed plumber.

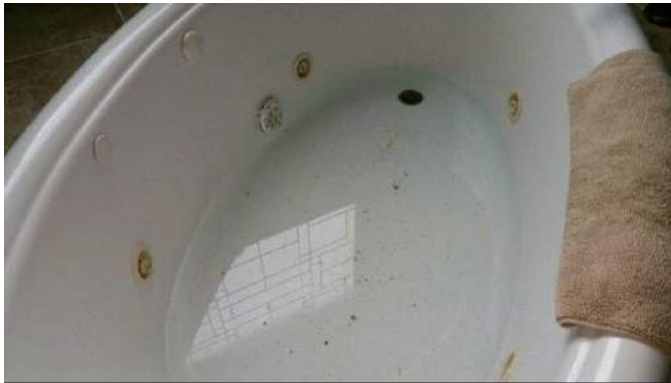
Jetted Tubs: Functional. Cleaning of the whirlpool tub prior to use is recommended.

Debris in the tub after operation

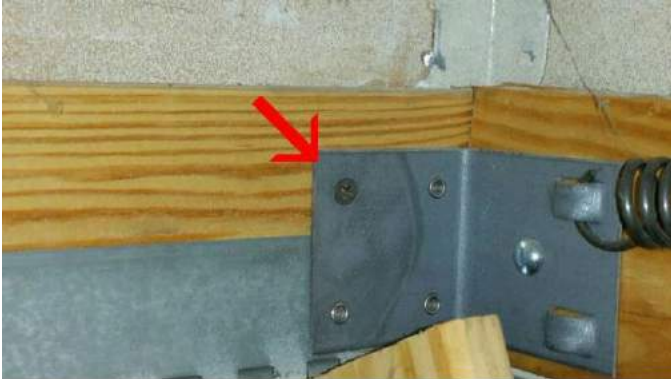
Condition: The pull down stairs are inadequately secured to the framing with drywall screws. The manufactures installation instructions require that 16D nails be used on all four sides of the stairs frame.
Repairs should be made by a licensed general contractor.

Drywall screws used to secure frame

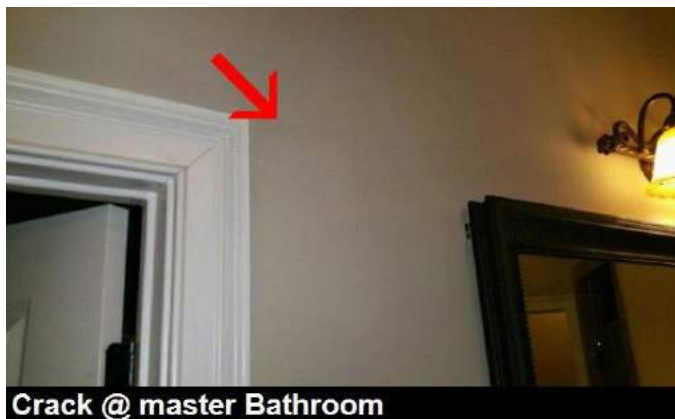
Type & Condition: Drywall. A crack was noted in the master bathroom next to the walk-in closet door. Compression cracks were noted at the foyer walls under the second floor walkway.
Further evaluation and repairs should be made by a licensed general contractor.

Crack @ master Bathroom

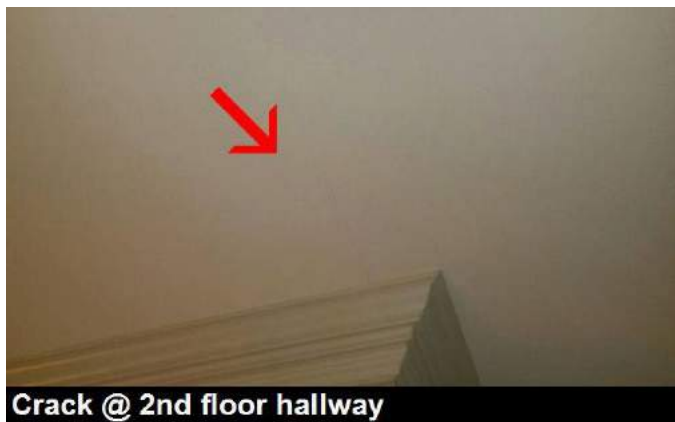
Type & Condition: Drywall. A crack was noted at the front 2nd floor ceiling near the stairs.
Multiple repairs were noted at the family room ceiling. The purpose of these repairs is unknown. Inquire with the homeowner about these repairs.
Further evaluation and repairs should be made by a licensed general contractor.

Crack @ 2nd floor hallway

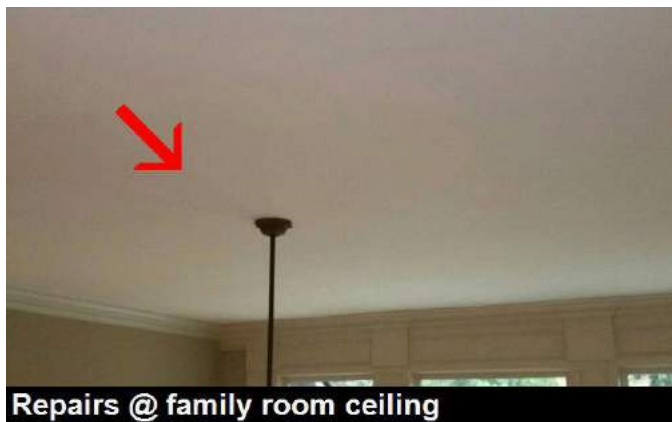
Repairs @ family room ceiling

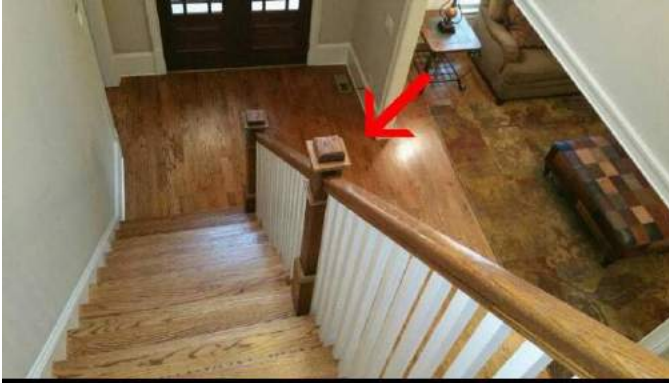
The second floor stairs handrail is not continuous for the entire flight of stairs. This does not comply with construction standards in affect at the time the home was constructed. This is also a potential safety hazard.

Handrail is not continious

Repairs should be made by a licensed general contractor.

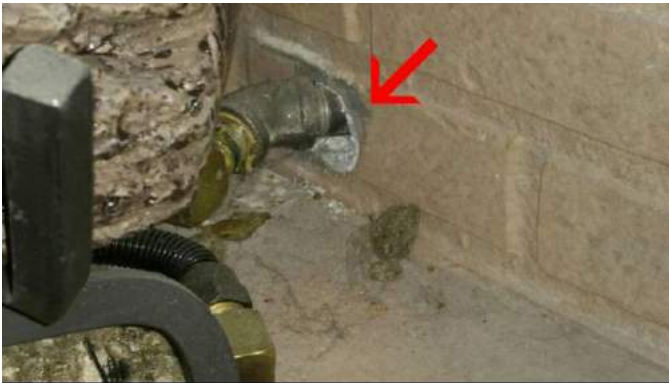
Seal gas line

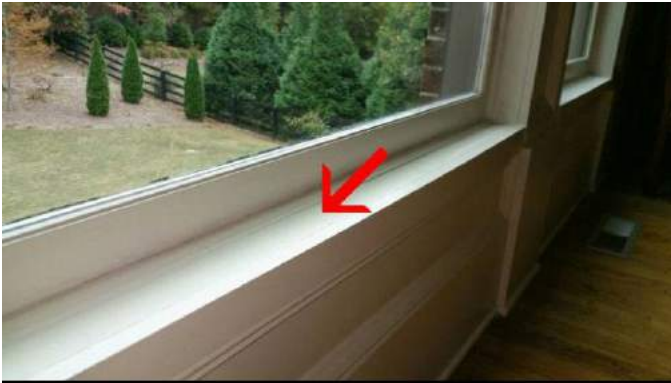
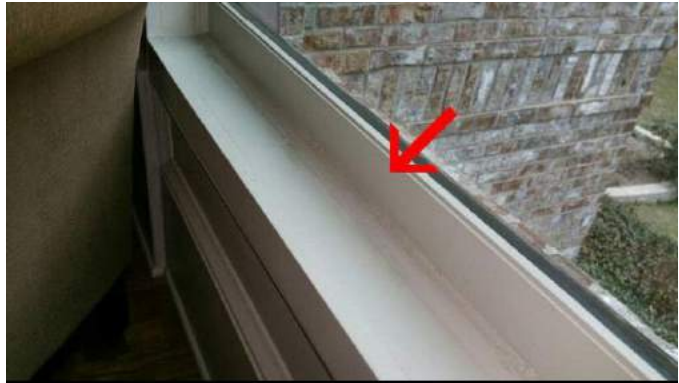
Previous repairs were noted around family room rear windows. Caulking and re-installed trim were noted. This appears to be the result of previous water entry. Inquire with the homeowner about the reason for these repairs. Concealed damage may be present.

Previous repairs

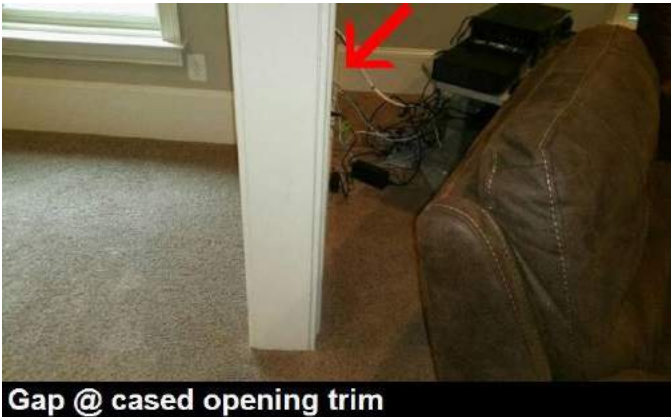
Loose trim was noted at the basement wall cased openings. This appears to be an installation/craftsmanship issue. Repairs can be made by a qualified contractor.

Gap @ cased opening trim
