Inspection Report

www.edificeinspections.com

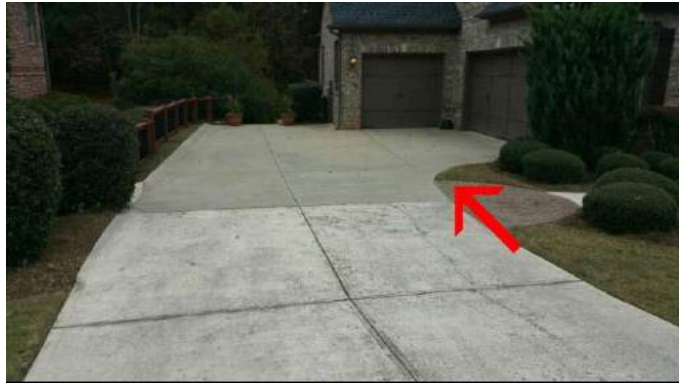
Condition: Surface deterioration and cracking were noted at the sections of the driveway closest to the street. The surface deterioration is not consistent with normal wear for the age of the property. Additional surface deterioration should be expected over time. The rear of the driveway has been recently replaced. Some typical cracks were noted at this section of the driveway.

Newer section of driveway

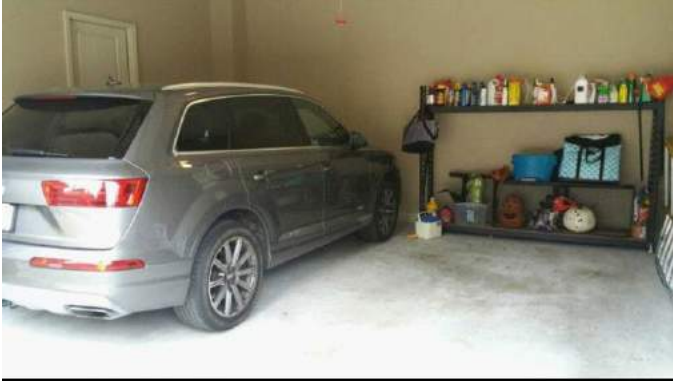
Stored Items: Stored items restrict viewing of the garage area.

Stored items limited view

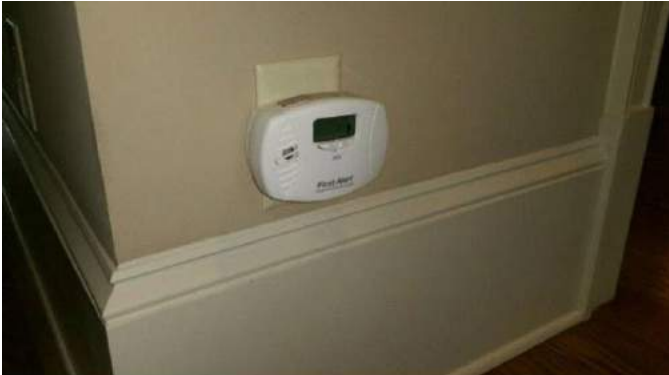
CO unit

Present: Yes, plugged into receptacles.

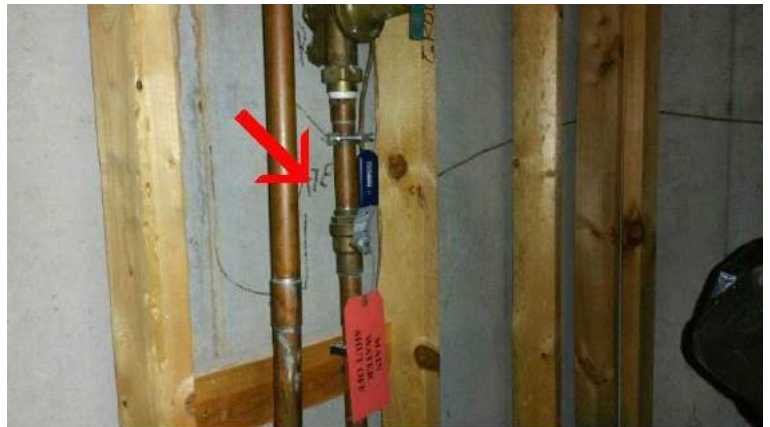
Main water shut off valve

Main Shut Off Location: Basement, Enters the front of the house.

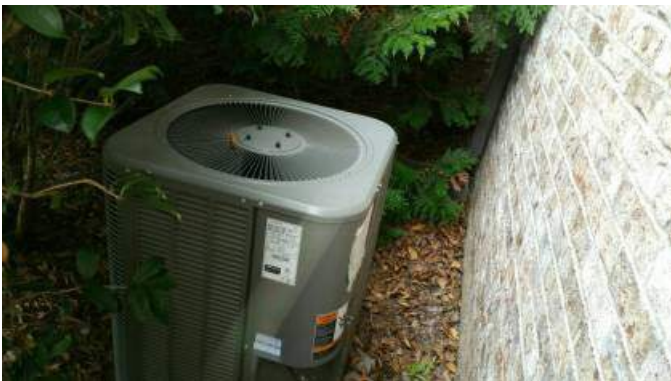
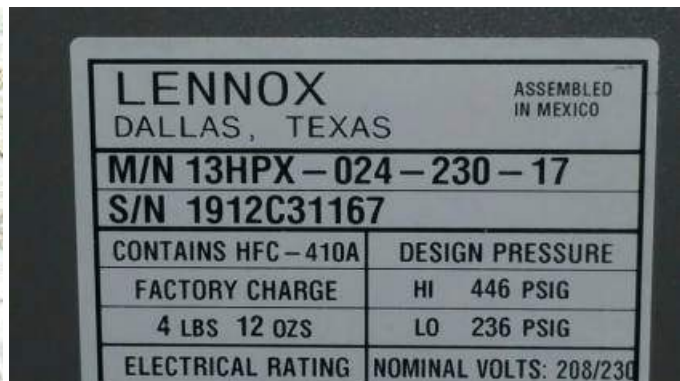
Condition: Functional. Due to the cool exterior temperatures only the function of the air conditioning system(s) could be tested. Adequacy of cooling could not be determined.

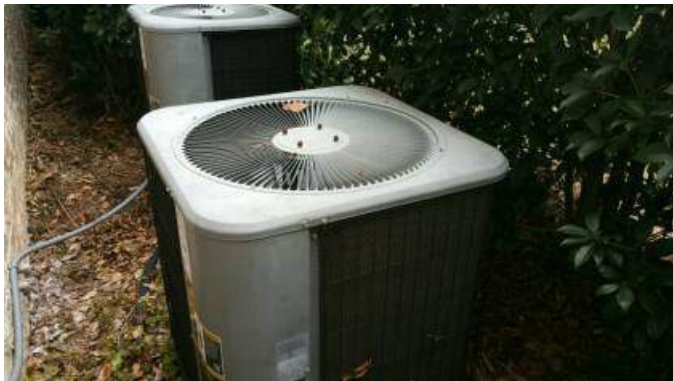
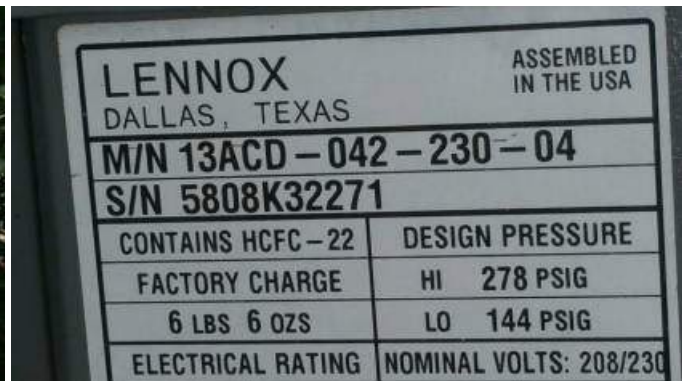
System Type: Central.
Power Source: Electric, 240 Volt.
Condensation Lines: Condensate line installed.
Normal Controls: Acceptable.
Manufacturer: Lennox.
Approximate Age in Years: 11.
Approx. Capacity in Tons: 3 1/2.
Condition: Functional. Due to the cool exterior temperatures only the function of the air conditioning system(s) could be tested. Adequacy of cooling could not be determined. The condensing unit has reached the end of its life expectancy. Replacement should be budgeted for.

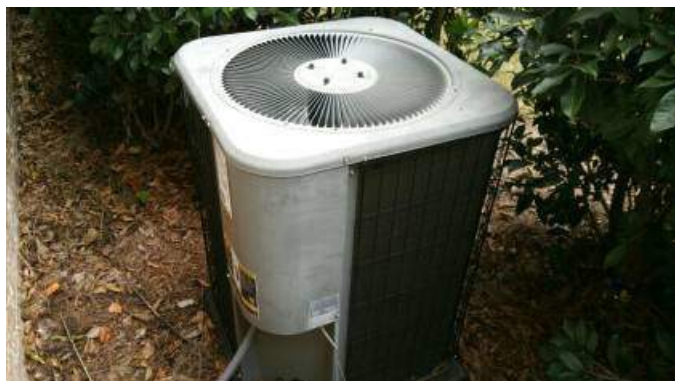
Condition: Functional. Due to the cool exterior temperatures only the function of the air conditioning system(s) could be tested. Adequacy of cooling could not be determined. The condensing unit has reached the end of its life expectancy. Replacement should be budgeted for.
